CCM Technical Maintenance Bulletin

Bulletin 12 - November 13, 2012

Hutchens Rocker Replacement

Replacement of Hutchens Rockers due to Bushing Wear

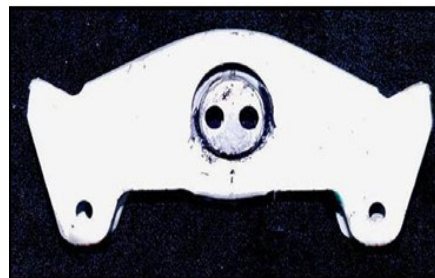
Photo 1: 7700 style 2-bolt rocker with worn bushing.

A 7700 style 2-bolt rocker bushing is shown in photos 1 and 2. As the rocker is exposed to loading, articulation, and the elements, the rubber on the bottom of the bushing will eventually be displaced and/or wear away. This allows the rocker to move up in the hanger toward the trailer frame, but the rocker will still pivot around the steel core of the bushing.

When the rubber wears away, the rocker may appear to become loose in the hanger. It is possible that the rocker can be easily moved by hand, and may even appear to “rattle” in the assembly.

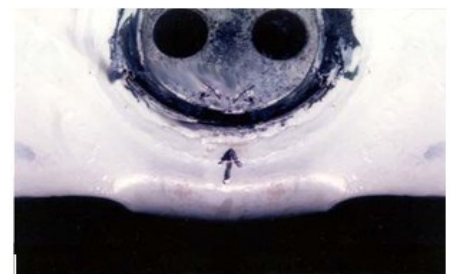
Photo 2: Close-up of worn bushing.

Even though the rocker will be loose in the hanger as the rubber wears away, it is not necessary to replace the assembly unless the steel core of the bushing is in contact with the steel hub of the rocker, or if the rocker is in a bind in the hanger and will not rotate. Note in photo 2 how the steel core of the bushing is closer to the rocker hub on the bottom side, but that there is still rubber between the two components. This rocker is still serviceable.

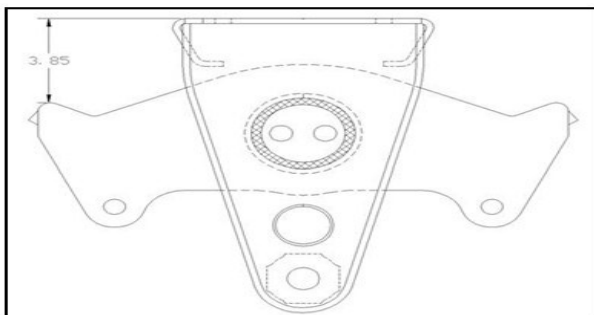
Both the 7700 (2-bolt) and 9700 (single bolt) rockers are shown level with the frame. These dimensions should be used to identify rockers that should be replaced because of worn rocker bushings.

Fig. 1: 7700 Rocker with new bushing.

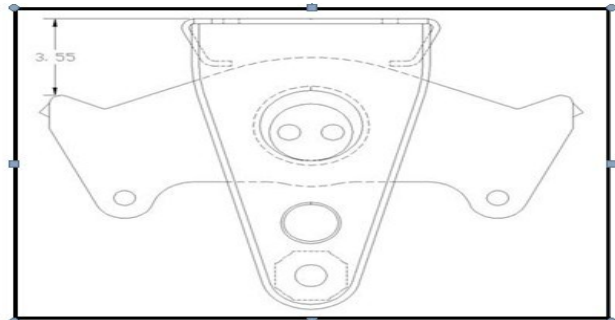
When the rocker moves upward in the hanger toward the positions shown in Figures 2 and 4, metal to metal contact is imminent either at the bushing, or at the top of the rocker. When the rocker is in contact with the top of the hanger as shown in Figure 4, it can no longer articulate and equalize the axle loads. In both cases, the rocker should be replaced before further damage occurs. Prior to this amount of displacement, the rockers are still functional although the articulation may be limited.

Fig. 2: 7700 Rocker with worn bushing.

Replacement should occur before the rocker becomes worn through the bottom, and before the hanger becomes damaged from contact with the rocker. The sketches on the following page will provide guidelines for determining if replacement of the rocker is necessary.

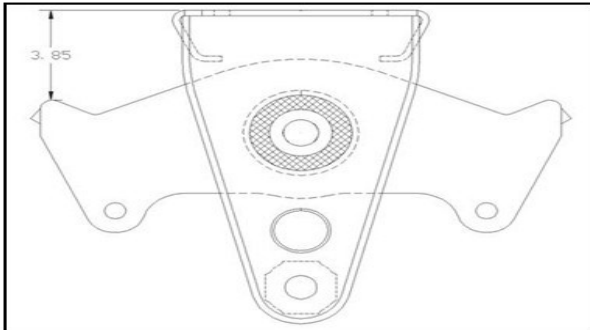
Fig. 3: 9700 Rocker with new bushing.

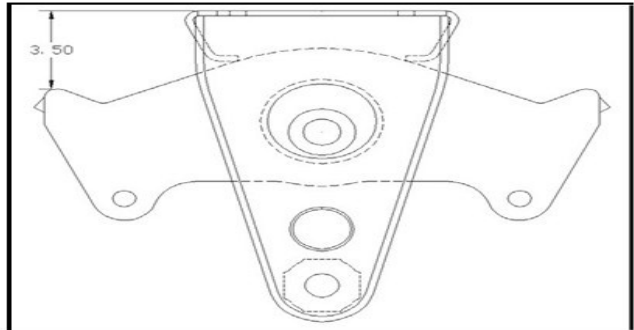
Fig. 4: 9700 Rocker with worn bushing.
