Technical Bulletin

No. 29

Topic: Rim Replacements

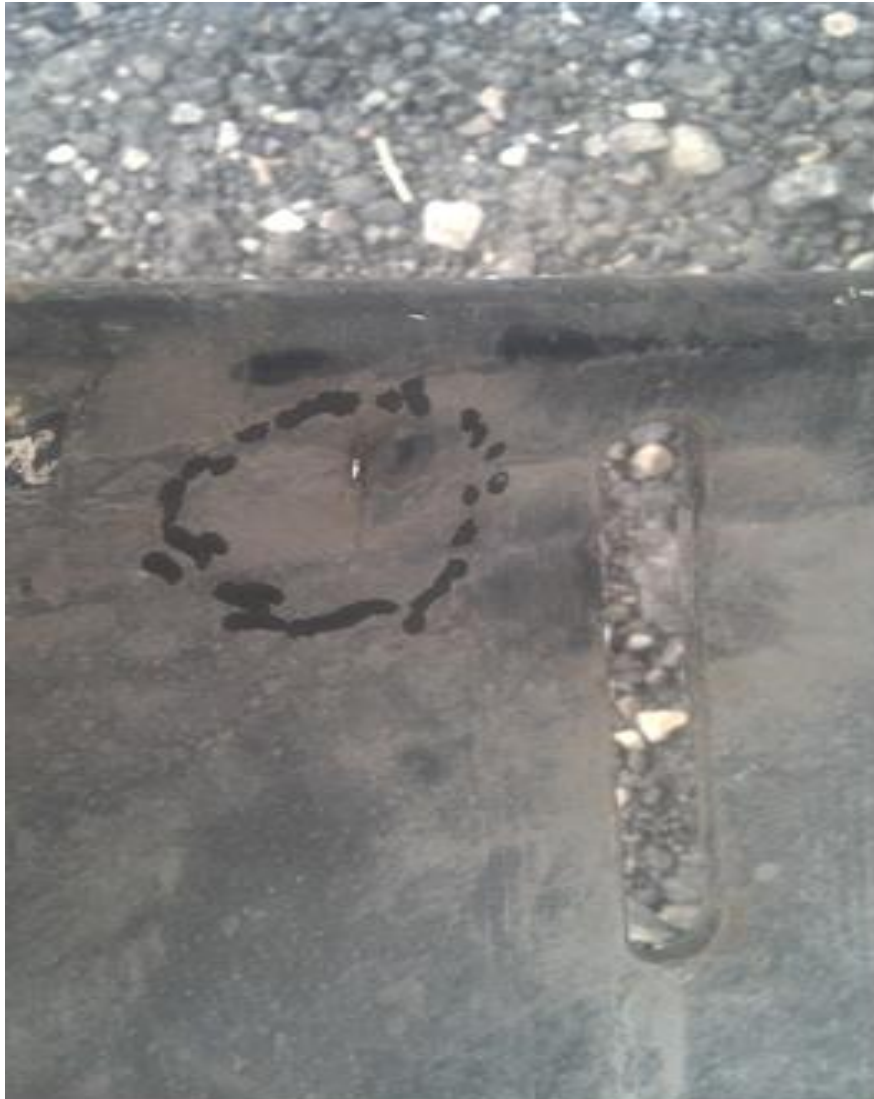
Light through the raised portion of the stop. Not Damage

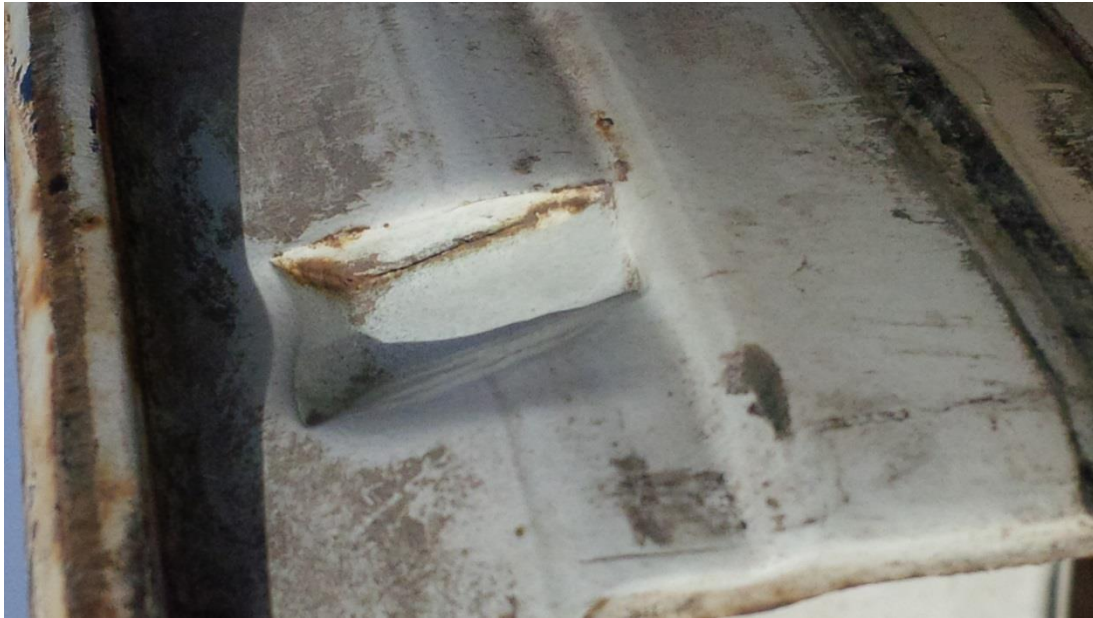
Close up of raised area of the valve stem locator from the bottom (inside) of rim.
Cracks in the paint only no damage evident

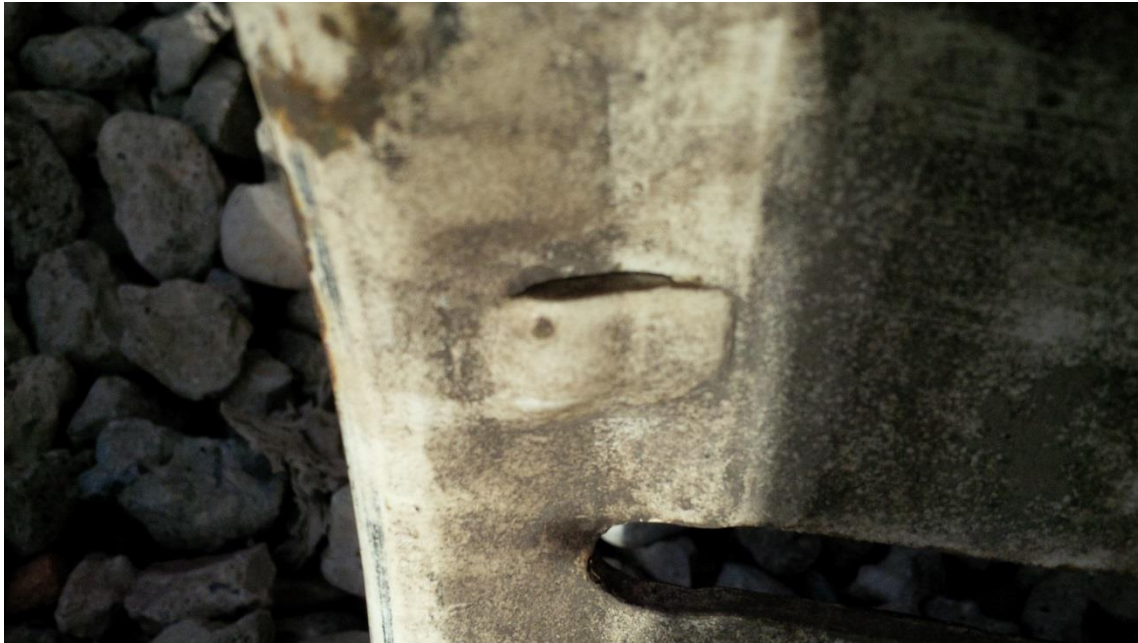
No Damage. Cracks in coating only

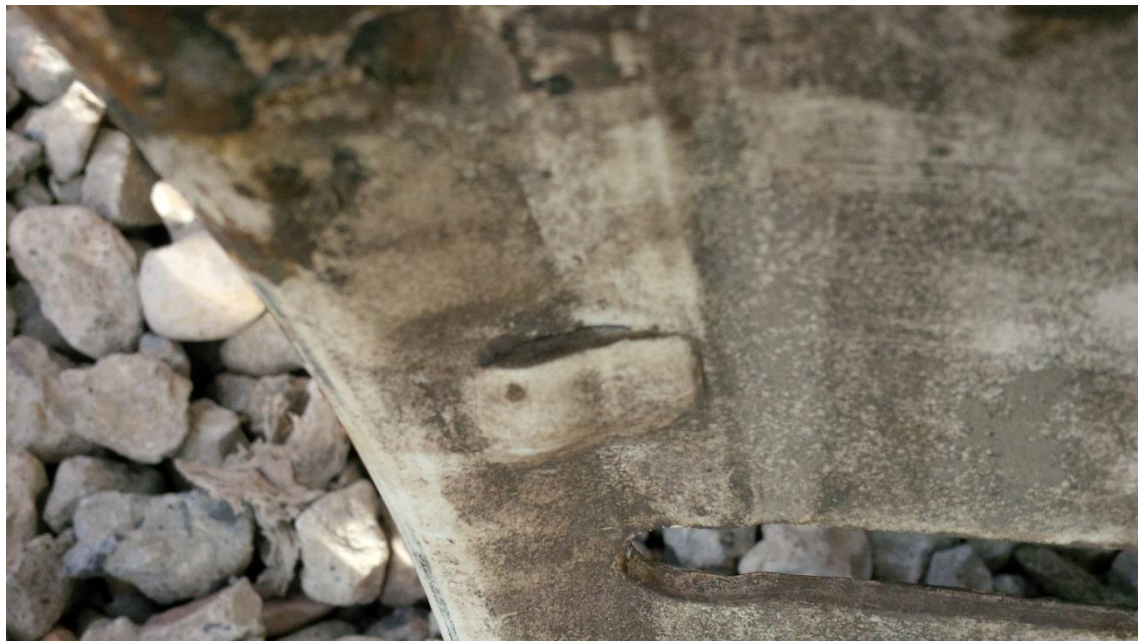
Even though light can be seen between the raised portion of the stop and the rim base, this is not damage
