Technical Bulletin No. 28

Published: 20 January 2021

Topic: <u>USED RIM INSPECTION PROCEDURE</u>

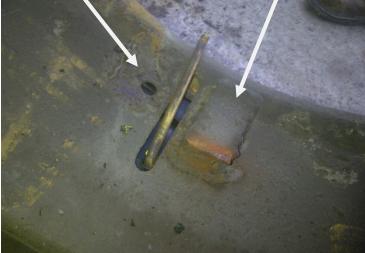
Improper previous repair to rim. Replacement valve stem locator welded

- b. Missing valve stem locators
 - c. Missing or illegible matching characters
 - d. Rim bases where matching lock-rings cannot be sourced
 - e. Pitting from corrosion to either rim base or lock-ring

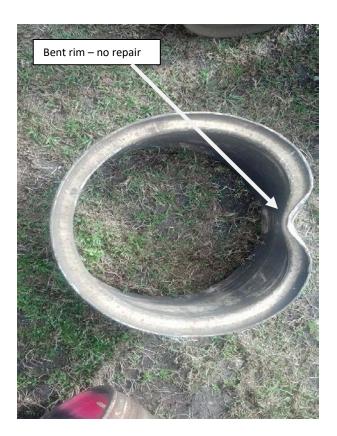
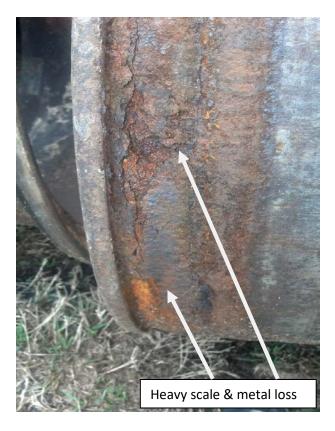
Heavy corrosion, not repairable
