**Published:** 8 January 2021

**Topic:** KWIK/Dorsey Rear Bolster Corrective Action

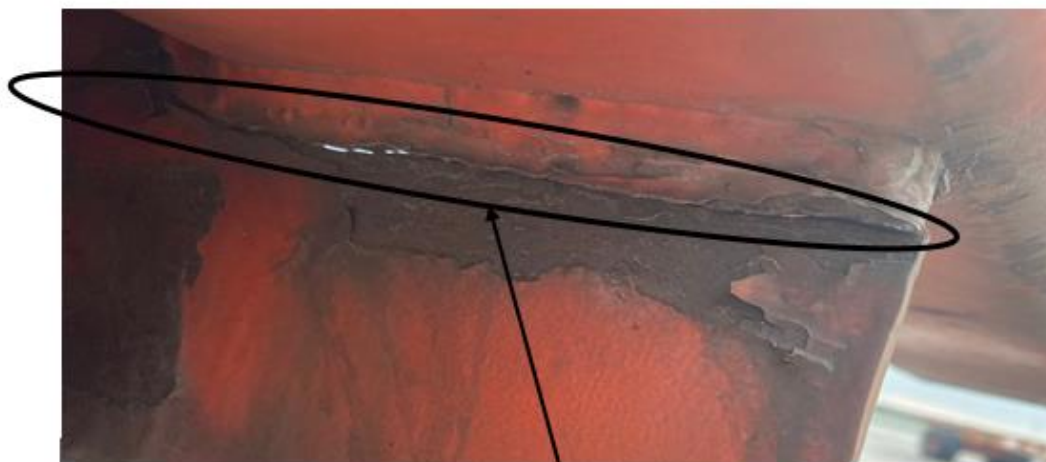
The defect observed is identified as a crack running across the bottom width of the rear bolster on both sides. In the more severe cases the crack either extends up the rear vertical weld on the rear bolster and/or fractures the main rail web at rear of the bolster.

Typical Crack

Repair description      Disconnect ABS. Remove paint from affected areas, stop drill and “V” all cracks. Weld all cracks and Stop drill holes, and install gussets per specification. Repaint all welding in matching color. All gussets are to be painted YELLOW only. Reconnect ABS. All painting is to be taped and blocked to ensure a professional appearance upon completion. Time allowed includes all prep and finish work required.
