## Technical Bulletin

No. 43

**Topic:** Hyundai 40/45 Main Rail Failure

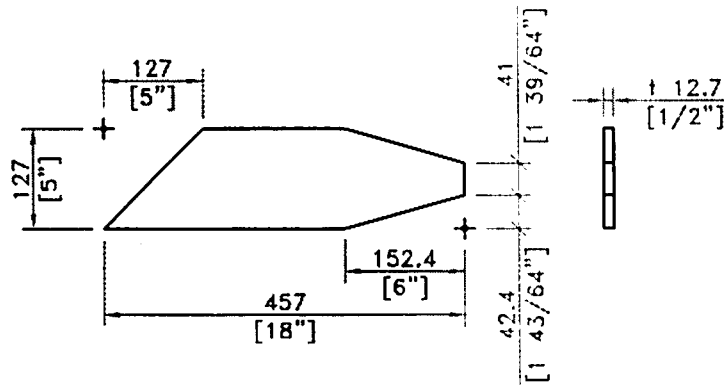
Minor repair is identified by a crack in the bottom horizontal flange only directly adjacent to the expander transition. The crack does not extend into the rail vertical web. Minor repair procedure as follows:

1. Using a 3/16" bit, stop drill the crack in the main beam at its highest point.
2. Carefully grind a bevel in to all cracks to ensure 100% penetration
3. Weld all cracks using carbon steel rods such as E7018 or equivalent
4. Grind all surfaces as required to remove excess buildup
5. Install doubler plate as depicted in attached drawing RFC-025 underneath the bottom flange as depicted in attached repair procedure drawing

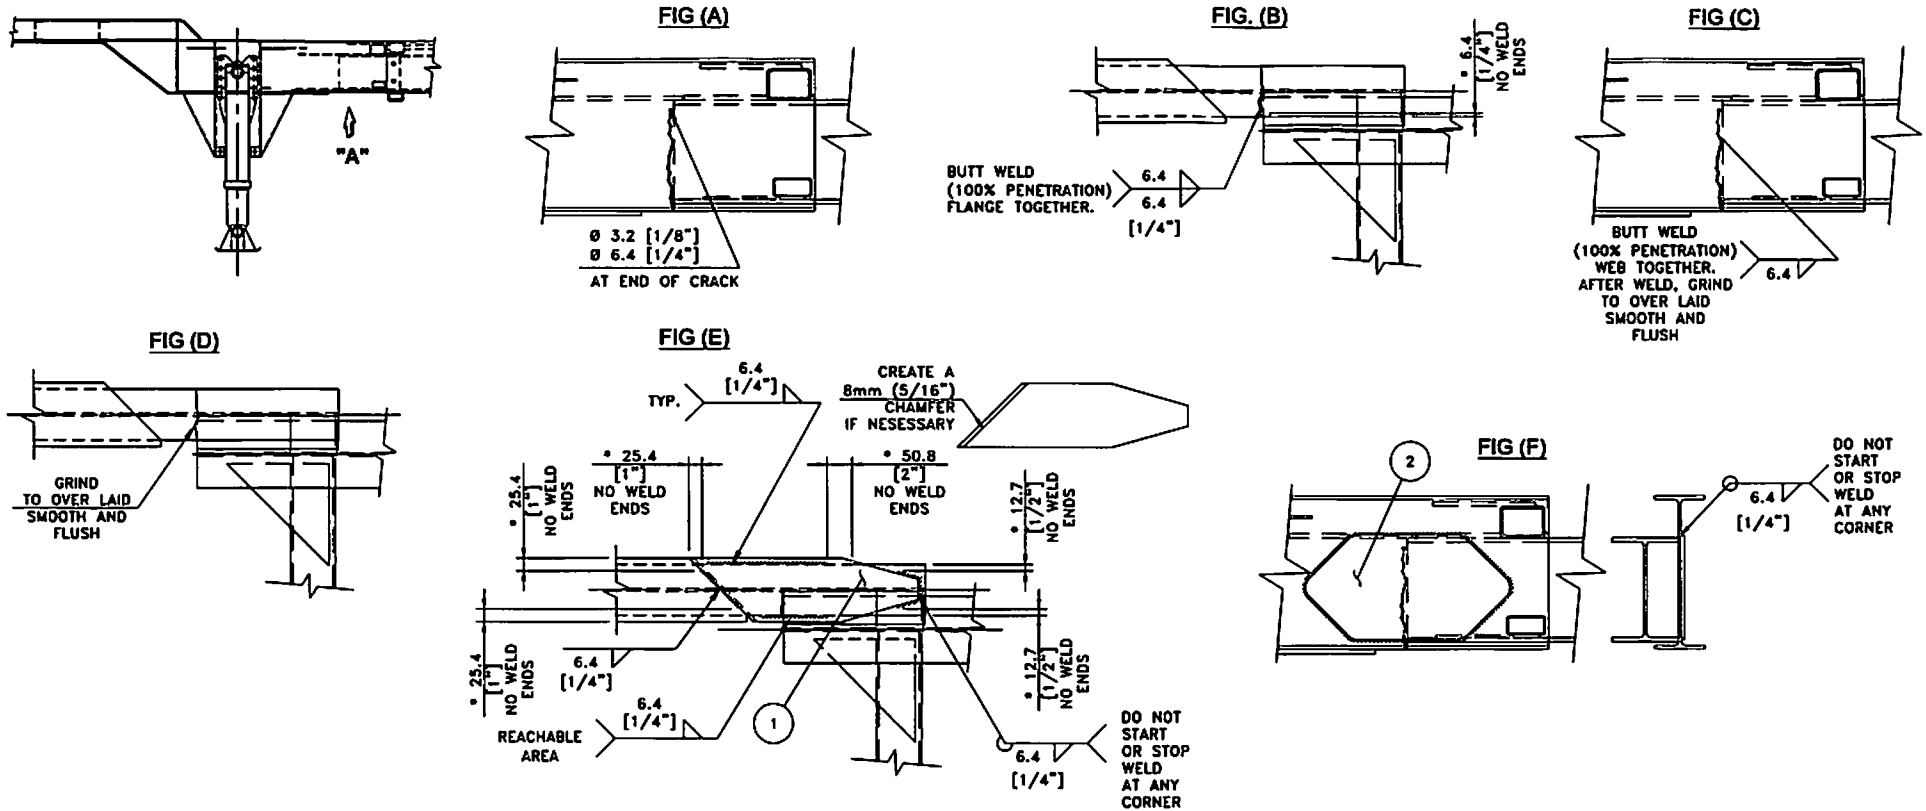
# REPAIR METHOD FOR 40'/45' EXT-NO 1

Major repair is identified by a crack in the bottom horizontal flange directly adjacent to the expander transition that extends into the rail vertical web as depicted in the attached drawings. Major repair procedure is as follows:

**\*WITH MAIN BEAM WEB CRACK\***

1. Using a 3/16" bit, stop drill the crack in the main beam at its highest point.
2. Carefully grind a bevel in to all cracks to ensure 100% penetration
3. Weld all cracks using carbon steel rods such as E7018 or equivalent
4. Grind all surfaces as required to remove excess buildup
5. Install doubler plates as indicated on the attached drawings to the outside of the main rail and the underside of the bottom flange
6. Ensure that all repairs are cleaned primed and painted

- CLEAN AFFECTED AREAS PRIOR TO ANY WELDING.
- DRILLING 3.2 TO 6.4 mm (1/8" TO 1/4") DIAMETER, STOP HOLE AT END OF CRACK (FIG. A).
- VEE GROOVE ANY CRACKS AND BUTT WELD TOGETHER (FIG. B & C).
- GRIND WELDS THAT WILL HAVE REINFORCEMENTS OVER LAID SMOOTH AND FLUSH (FIG. C & D).
- APPLY REINFORCEMENT AS SHOWN (FIG. E & F).
- EXCEPT INDICATIONS 6.4 NO WELD ANY OPEN ENDS.
- CLEAN WELDS AND AFFECTED AREA AS REQUIRED AND PRIME AND FINISH PAINT AS REQUIRED.
