Consolidated Chassis Management 500 International Drive Budd Lake, NJ 07828 610.438.2657 www.ccmpool.com

No. 39-2

## Technical Bulletin Published: 21 October 2014 Topic: Tube and Flap Selection and Repair Requirements

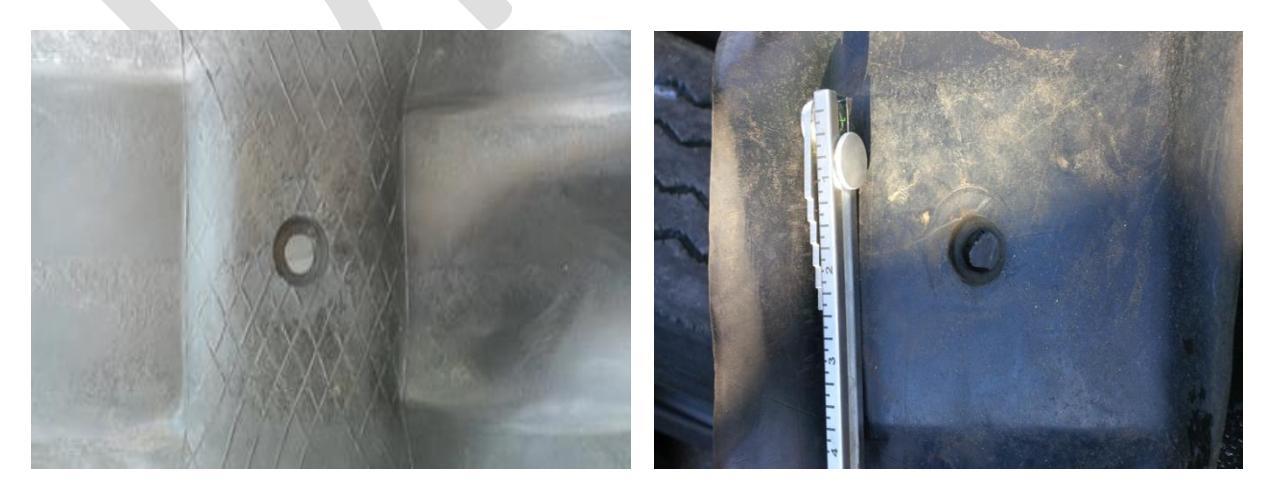
- 1. Flaps may be reused provided they are not cut, torn, doubled or otherwise present a hazard to the tube and stem. NOTE: particular attention is to be paid to the condition of the valve stem reinforcement area. Any flap exhibiting abrasion and cracking in the stem reinforcement area or signs of stress are to be replaced
- 2. All flaps must be checked for reinforcement in the stem area. Flaps that do not have a sufficient stem reinforcement area such as illustrated below

OR are not accompanied by an approved metal stem protector plate in good condition are to be replaced.

3. All replacement flaps must have a 4 inch reinforcement in the stem area to properly protect the tube

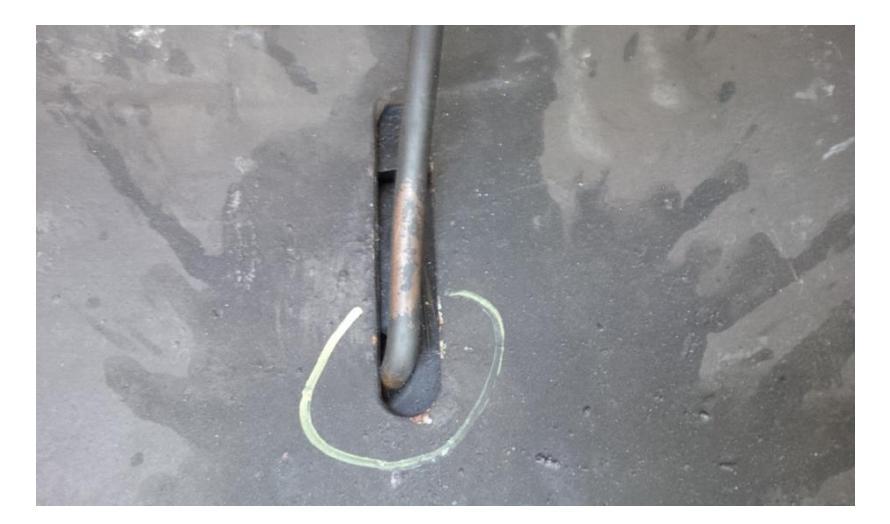
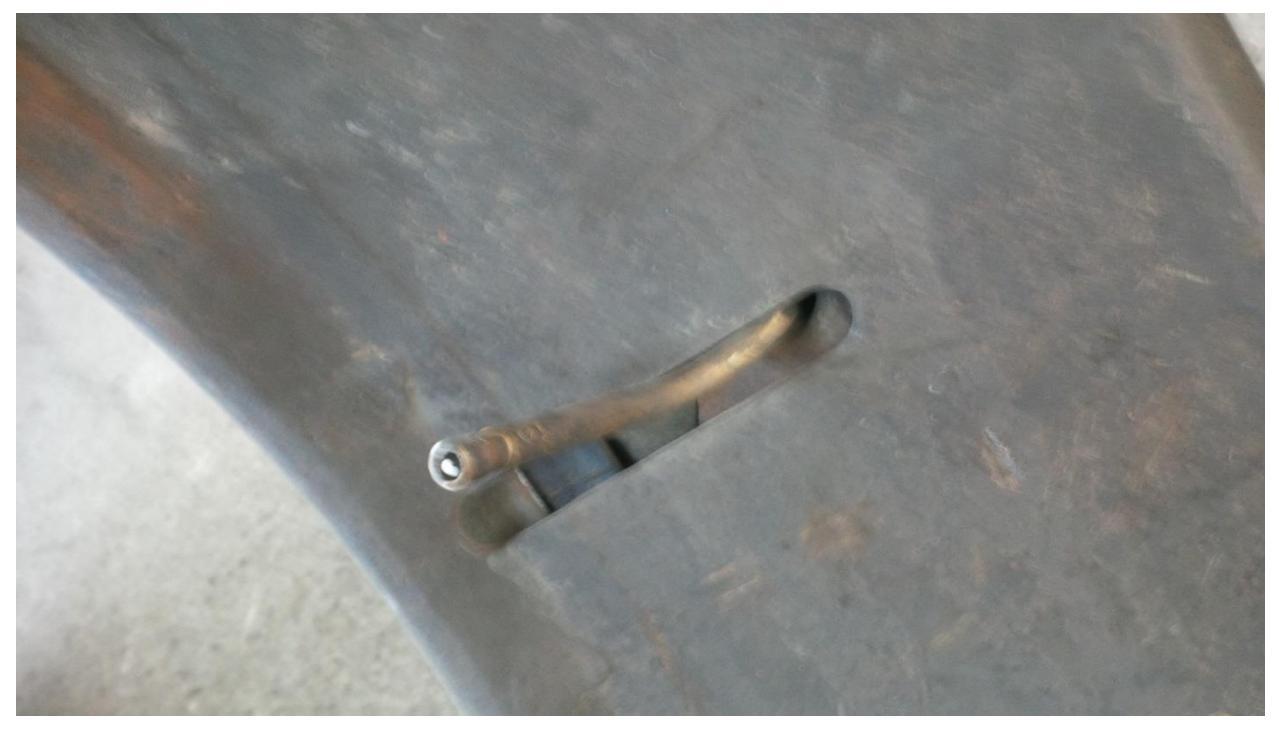
- 1. Care must be taken to ensure that the tube is properly positioned in the valve stem slot.
  - a. Stems that come out of the slot at an angle are not acceptable
  - b. Stems should not be in contact with the rim. Following are examples of unacceptable mounting

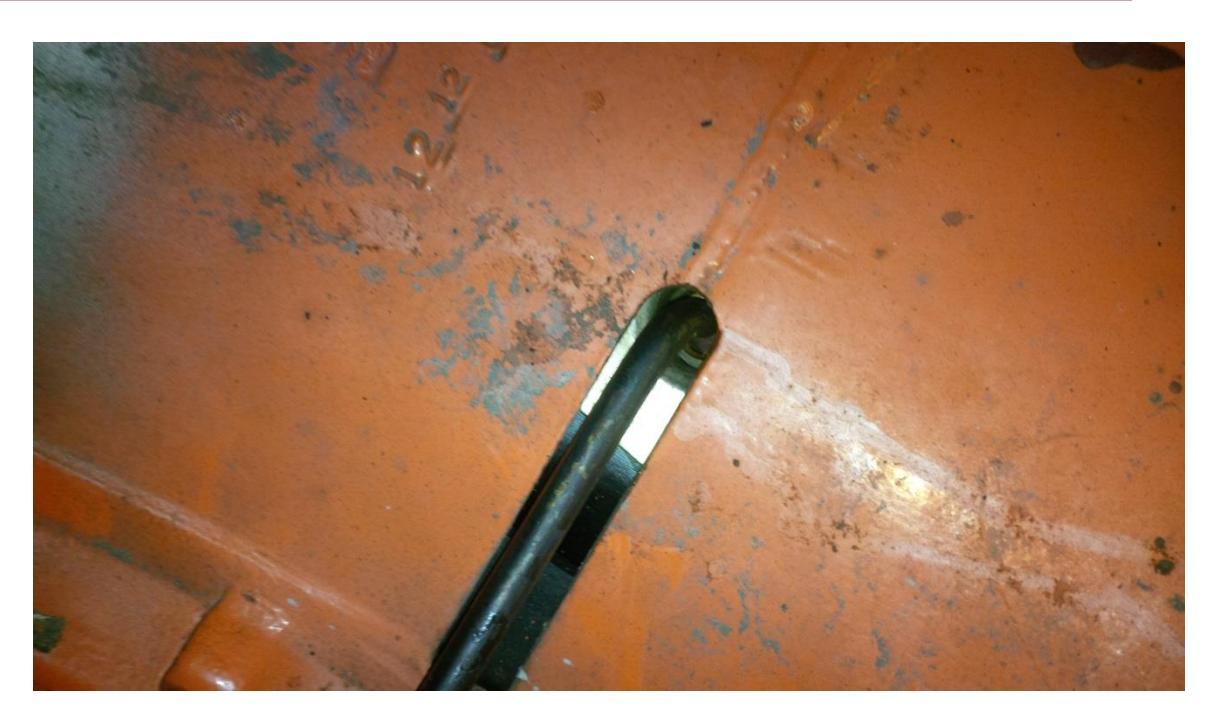
Bent or damaged flap protection plates are to be removed from service and are not to reused. Note examples of damaged improperly mounted protectors above and following
