CCM Technical Maintenance Bulletin

Bulletin 14 - June 14 2012

Tire Handling Damage

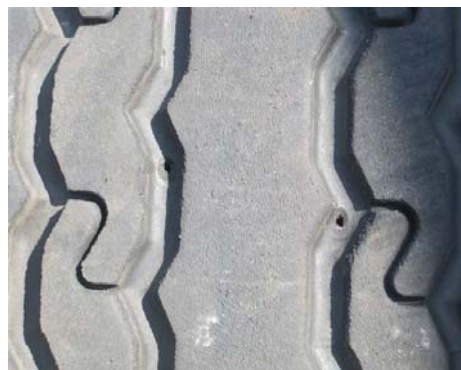
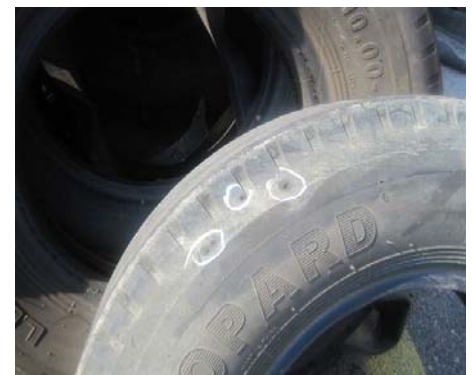
Drilled tires

Drilling the casing ruins the tires and will generally result in the loss of a capable casing. It also results in the loss of a reusable tube. It should be noted by all parties that this practice is not acceptable under any circumstances.

During recent facility reviews we had noted some instances where tires were drilled to facilitate the rapid deflation of the tire.

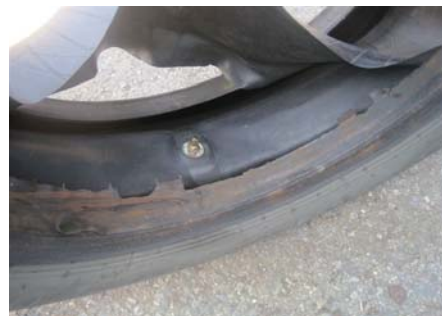
It has also come to our attention that proper care is not being taken at the time of dismounting to protect the valve stem. Recent reviews of tire casings also revealed several instances of valve stems being cut off during the dismounting process. It should be noted that CCM places a high priority on the recycling of tire tubes and urges the repair vendors to make every effort to preserve the integrity of tubes when removing tires from the rim.

Sheared Valve stem
