Topic: Loadcraft / Monon / Hyundai Slider Rail Modifications

Slider Tube Repair Procedure

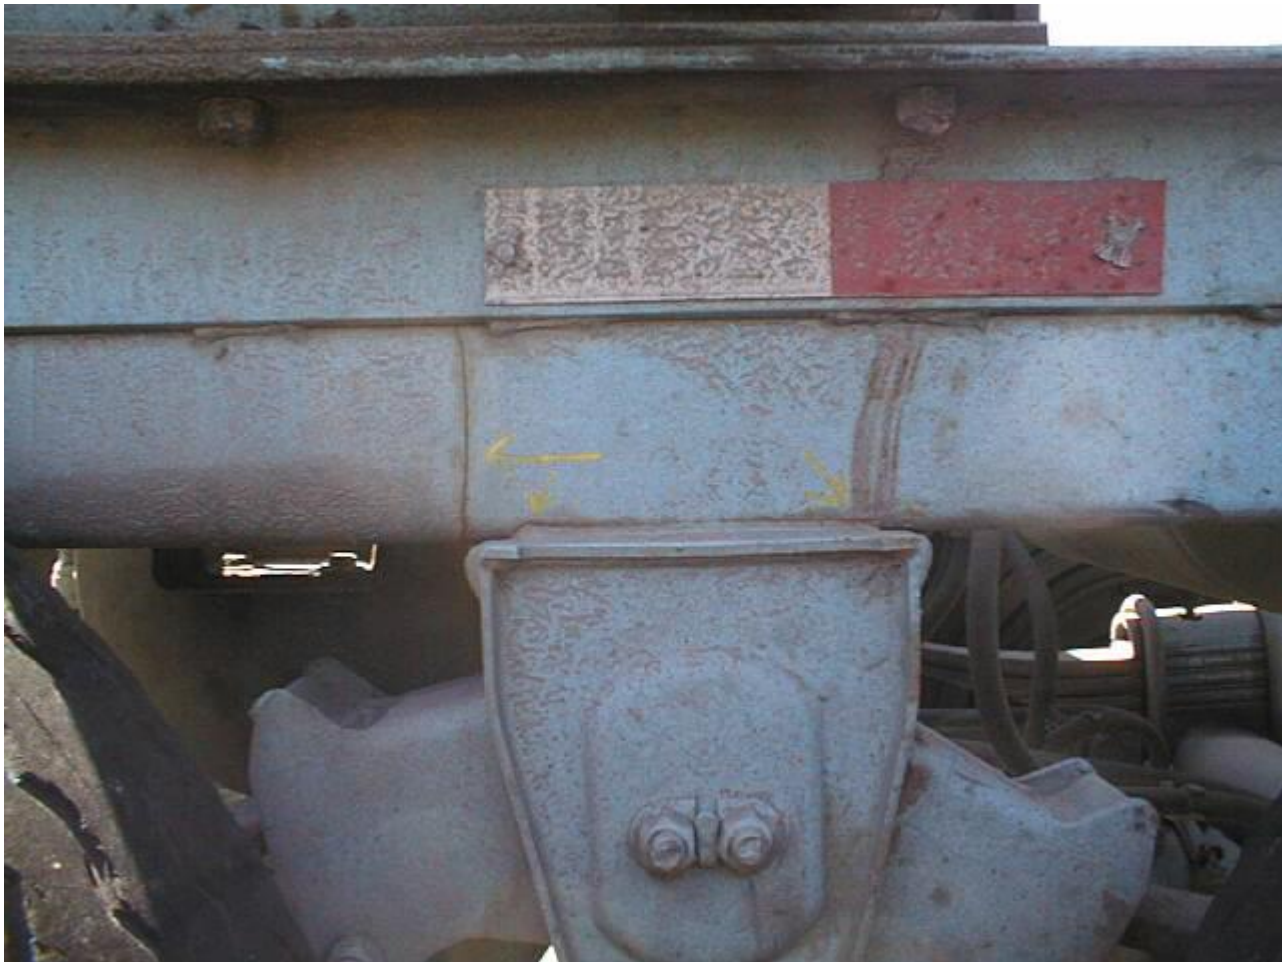
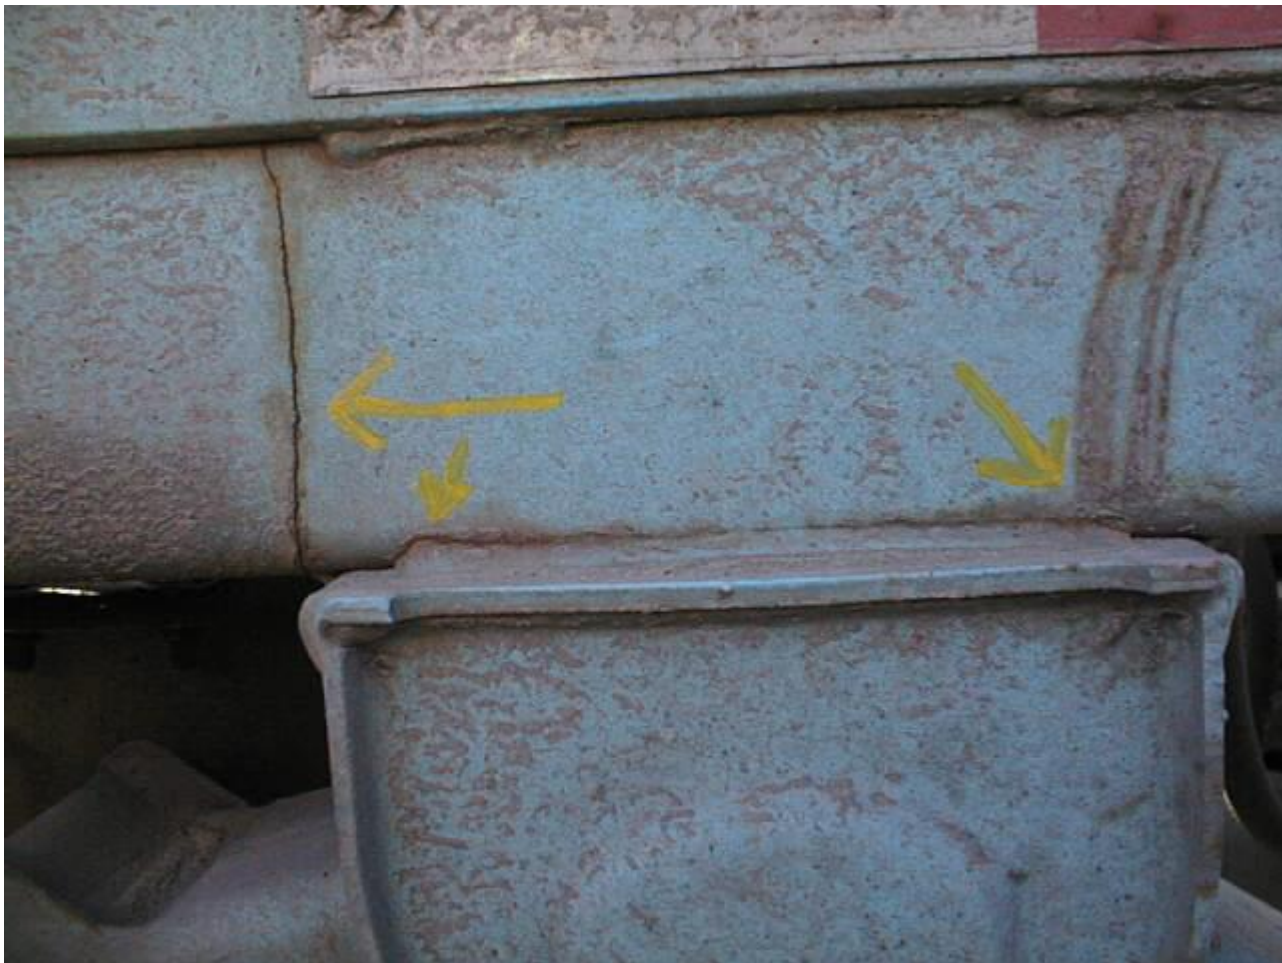
Individual cases have been found where stress cracks have developed in the slider tube at the center spring hanger

Remove tires

Stop-drill and weld crack

Clean surfaces to be welded

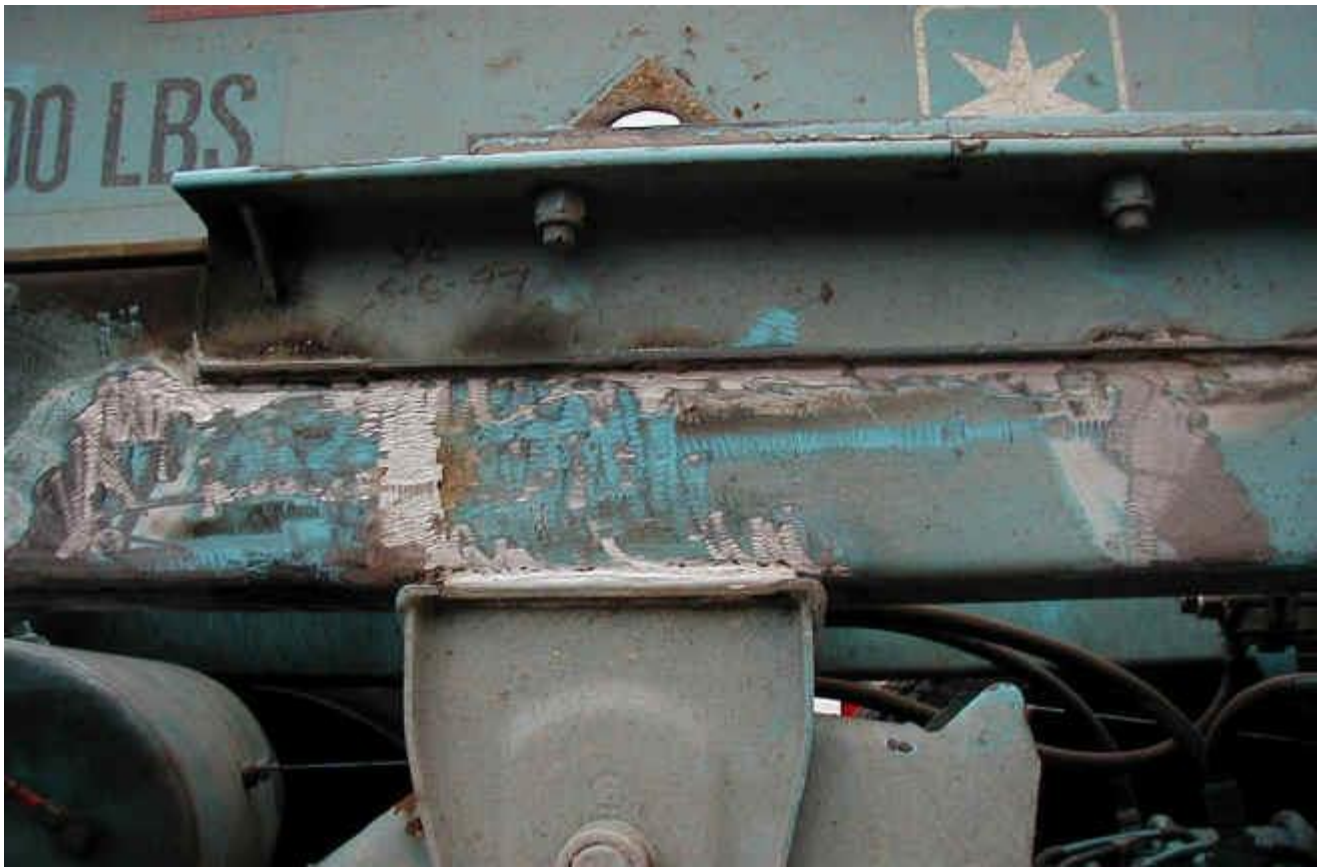
Scarf air tank bracket loose from frame

Note – do not remove tank from bracket

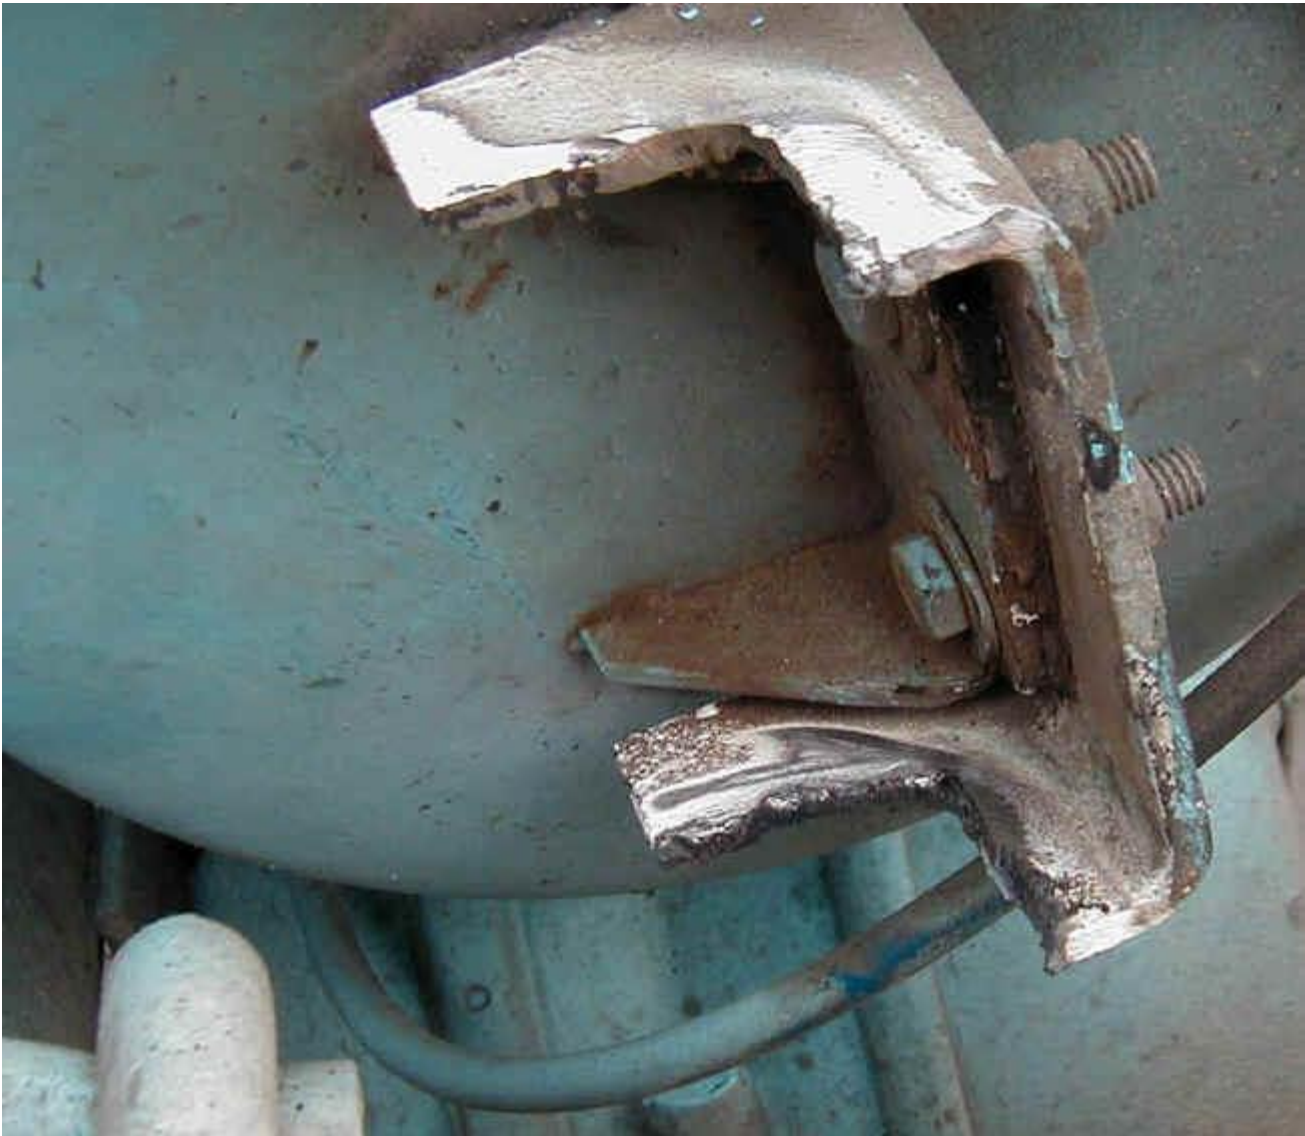
Trim back connecting welds at the front/outside/rear of spring hanger and under the slider retainer

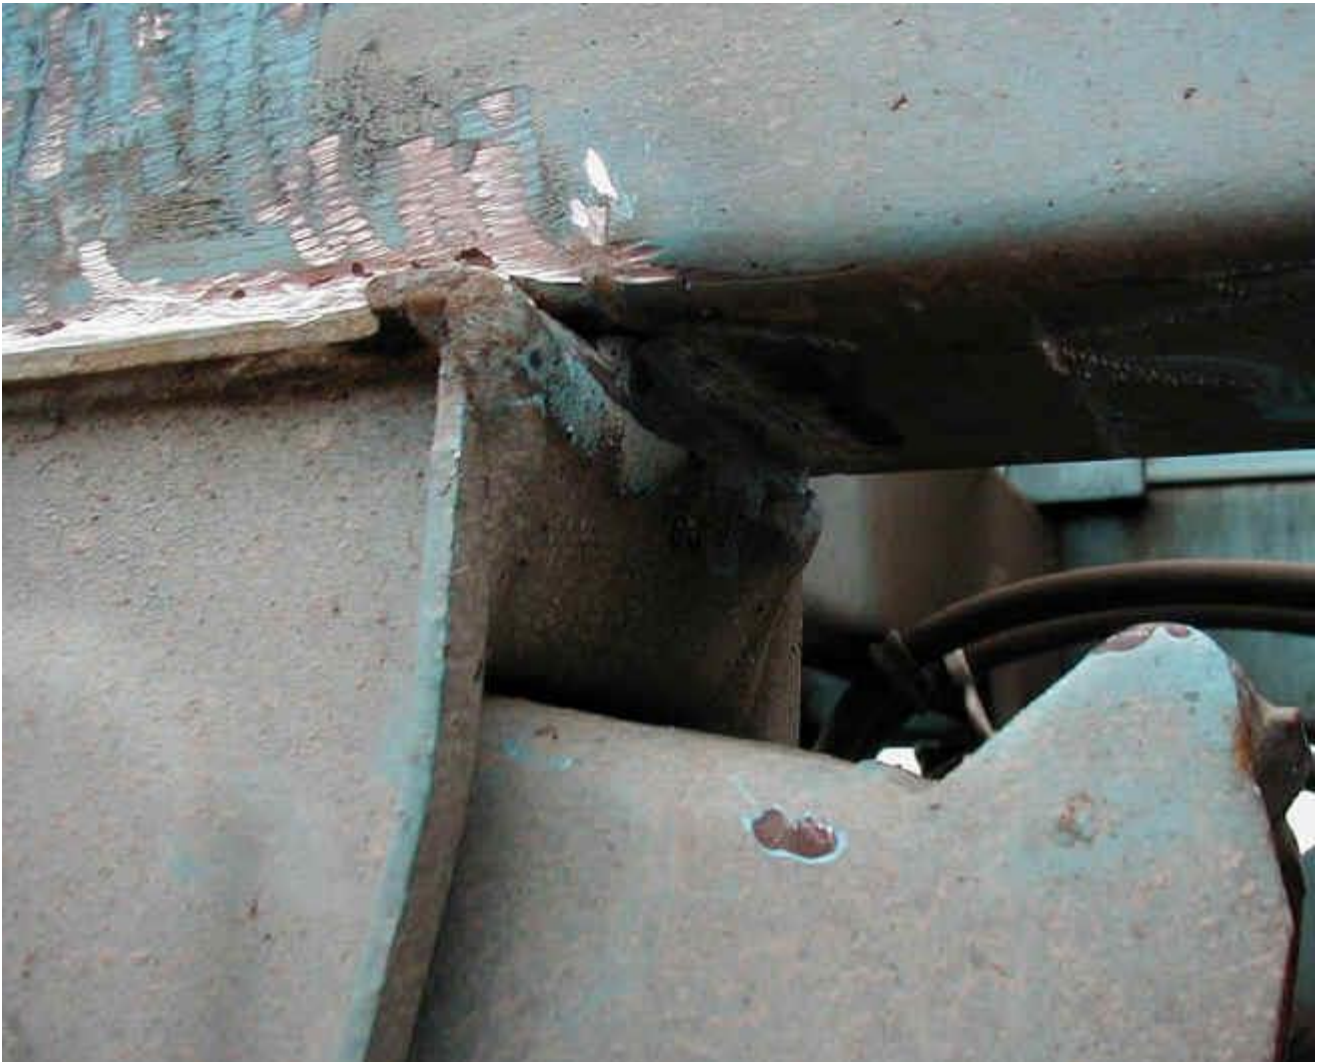
Remove material from kits as per the below diagram. Dimensions shown will vary slightly due to minor differences in chassis construction.
